# **Otter Tail County Lakes Assessment**

**2013**

**Otter Tail County Soil and Water Conservation District  
Minnesota Board of Soil and Water Resources**

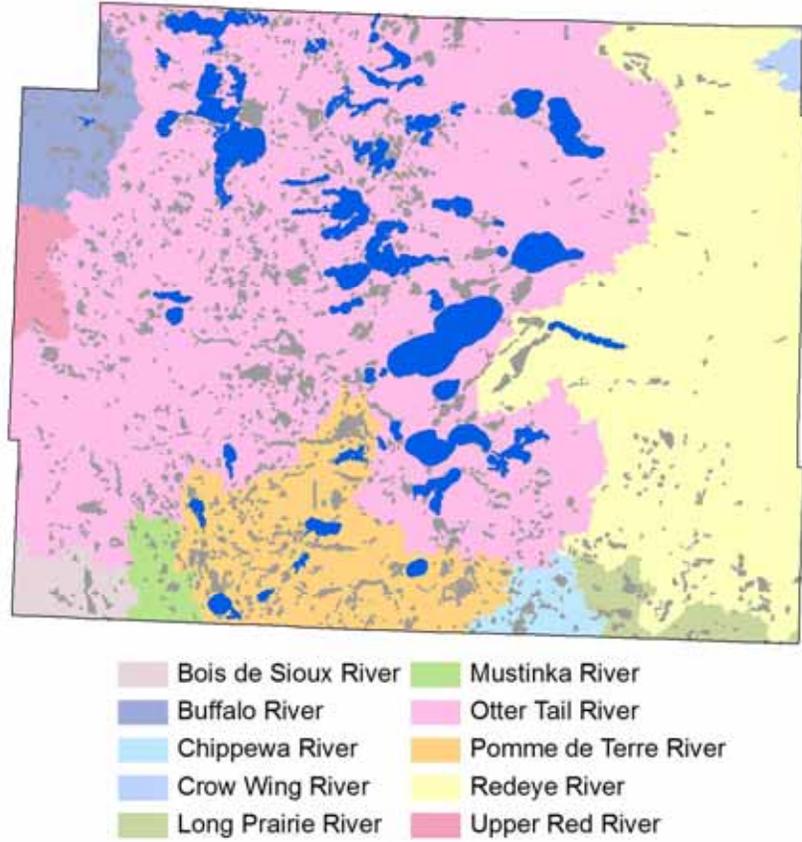
Figure 1. Major watersheds in Otter Tail County. The lakes featured in this report are highlighted in blue.

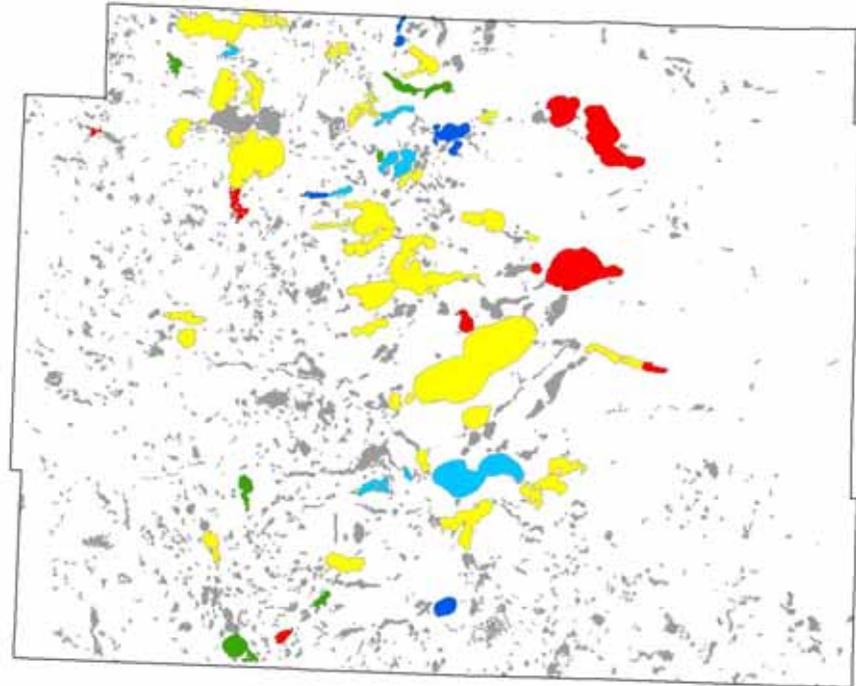
Figure 2. Otter Tail County lakes illustrating trophic states.

Most of the large Otter Tail County lakes fall into the mesotrophic category (Table 3-4, Figure 2).

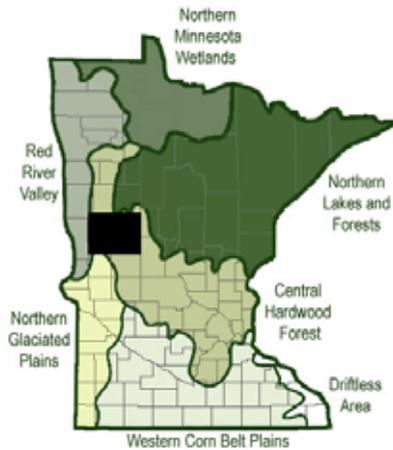
Figure 3. Minnesota Ecoregions. Otter Tail County is indicated in black.

All of Otter Tail County is in the Central Hardwood Forests (CHF) Ecoregion (Figure 3). This ecoregion is an area of transition between the forested areas to the north and east and the agricultural areas to the south and west. The terrain varies from rolling hills to smaller plains. Upland areas are forested by hardwoods and conifers. Plains include livestock pastures, hay fields, and row crops such as potatoes, beans, peas, and corn.

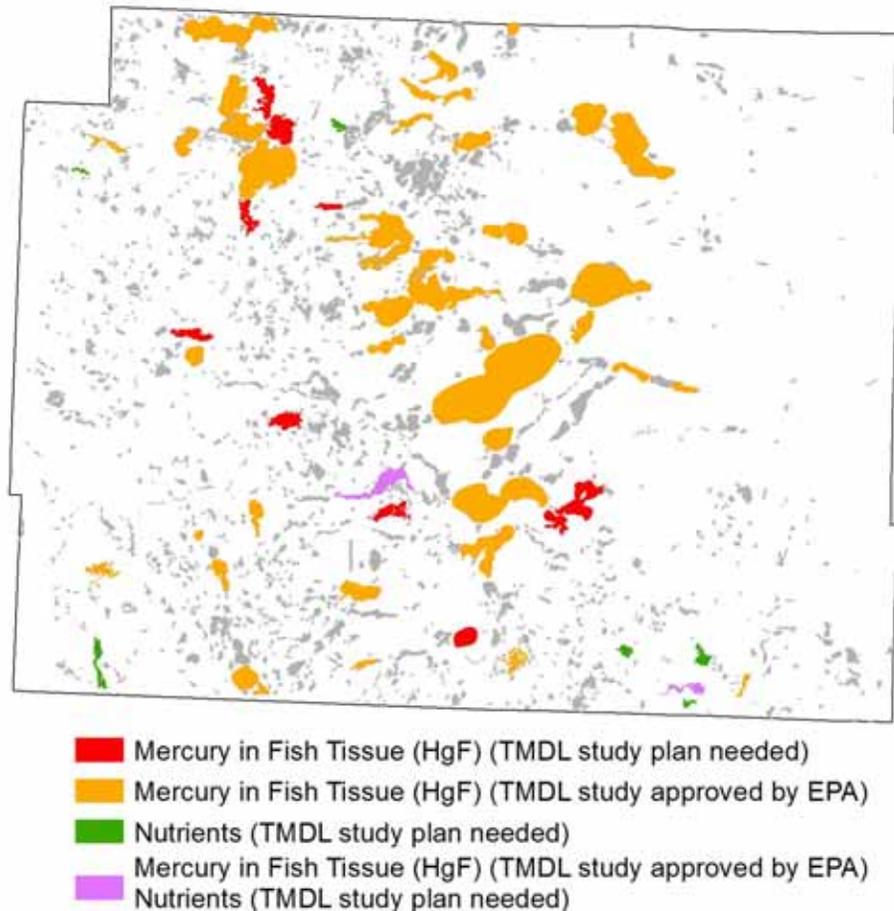
Figure 4. Otter Tail County lakes illustrating impaired waters status.

Many of the Otter Tail County lakes are listed as impaired for mercury; however, they are part of the statewide mercury TMDL (Figure 4). The remaining lakes in the county most likely are not listed due to lack of fish tissue data. There are statewide fish consumption guidelines available from the Minnesota Department of Health:

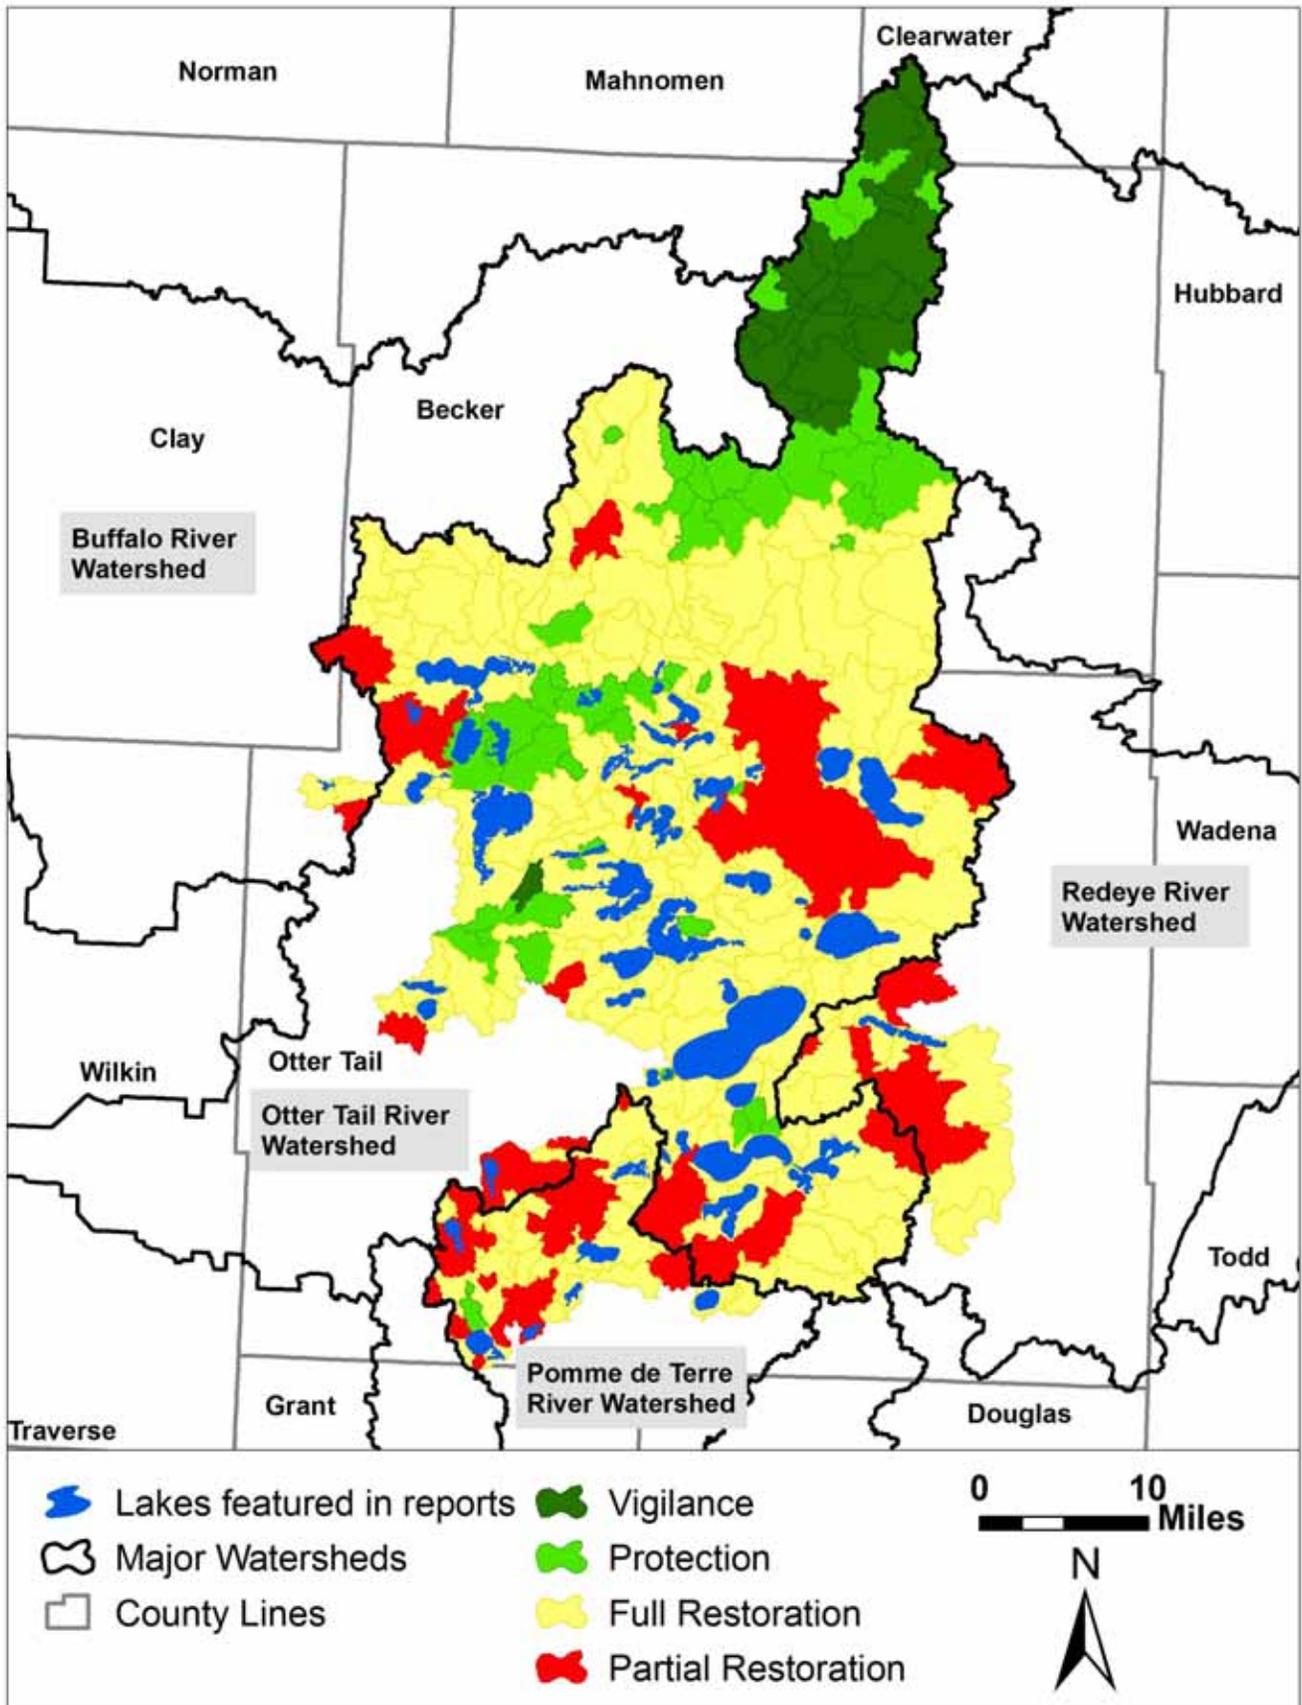
Figure 5. Map of lakesheds color-coded with management focus (Table 9).

Most of the lakes evaluated in this report have a full restoration focus (yellow, Figure 5, Table 9). The lakesheds around Clear, Hoffman, Paul, Swan, Tamarac and Wall Lakes are listed in the partial restoration (red, Figure 5, Table 10), which means they are more than 60% disturbed. The disturbance on these lakes includes development and agriculture.

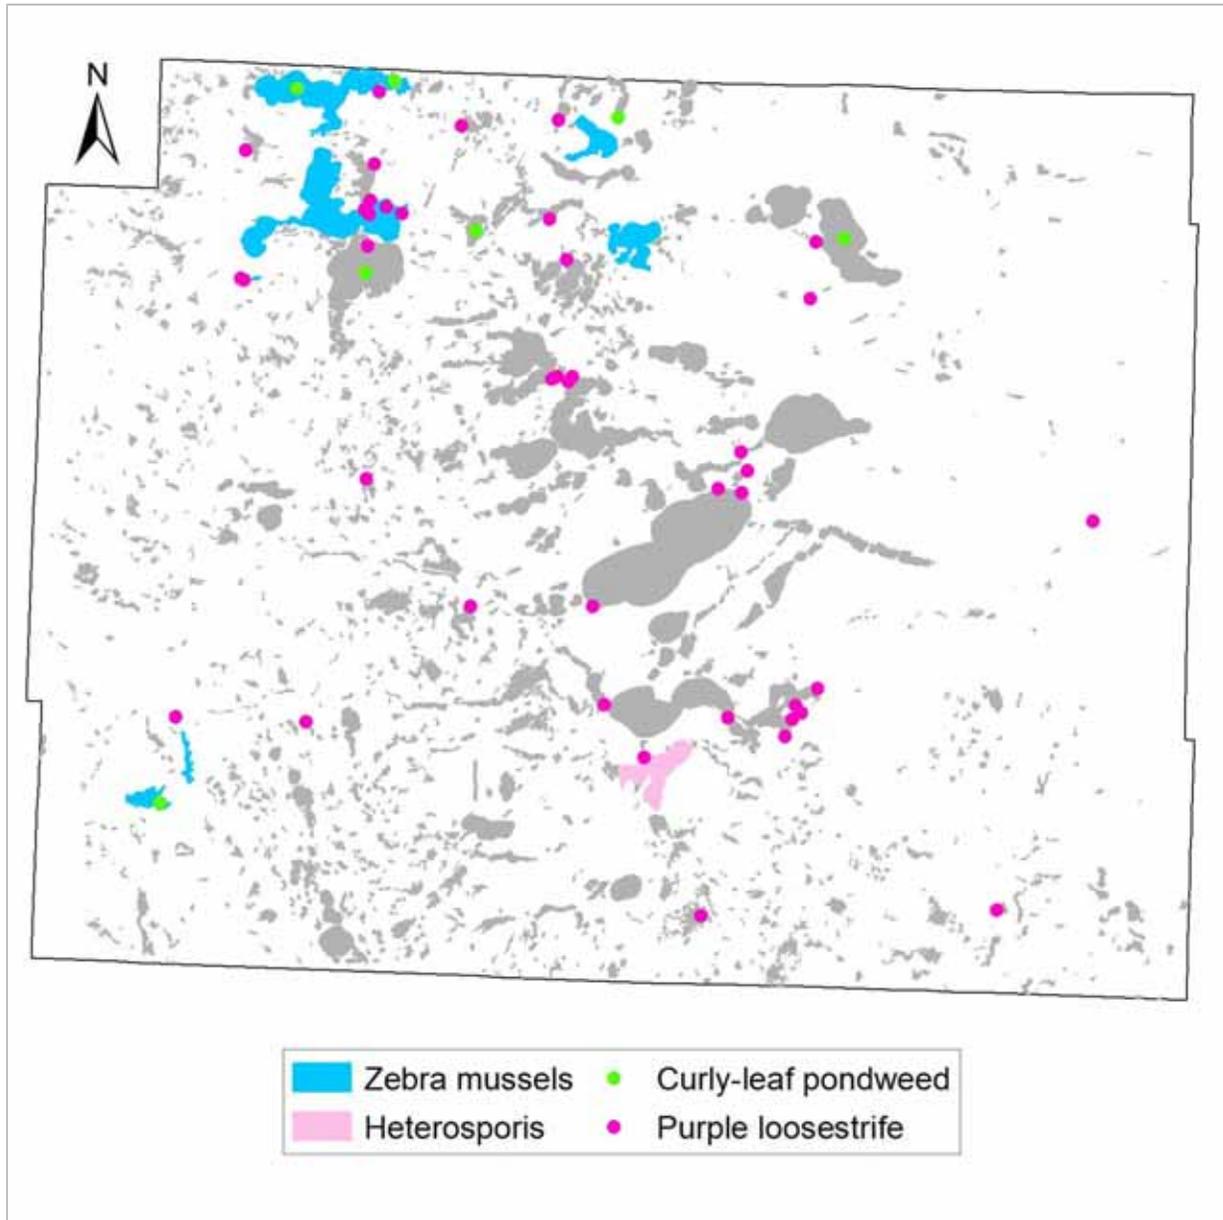
Figure 6. Otter Tail County lakes with aquatic invasive species and fish pathogens.

As of 2013, Otter Tail County has numerous infestations (Figure 6). The most difficult infestation to deal with is zebra mussels, since there is currently no method for controlling them.

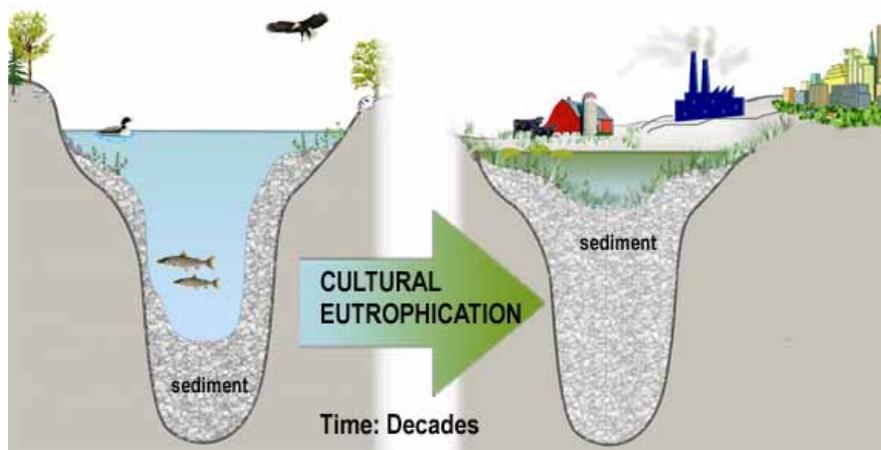
Around lakes, we have added many impervious surfaces to our environment. Impervious surface is any surface on land that is impenetrable to water and prevents its absorption into the ground. Examples include rooftops, sidewalks, parking lots, and roads. The more impervious surface in a concentrated area, the less surface there is for rain to be absorbed into the ground. Instead, it runs into lakes and streams, carrying nutrients and sediment from the land it flows over.

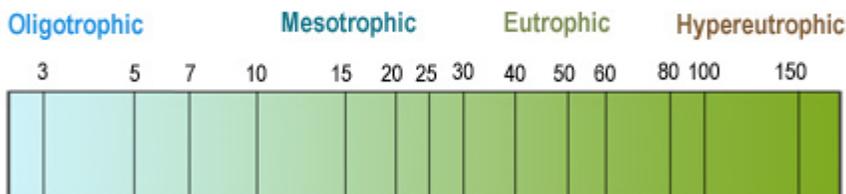
**Total Phosphorus (ppb) related to Lake Trophic State**

Figure 1. Phosphorus concentration (ppb) related to lake trophic state.

quickly. Total phosphorus (TP) is a better way to measure phosphorus in lakes because it includes both ortho-phosphate and the phosphorus in plant and animal fragments suspended in lake water. TP levels are more stable and an annual mean can tell you a lot about the lake's water quality and trophic state, as shown in Figure 1.

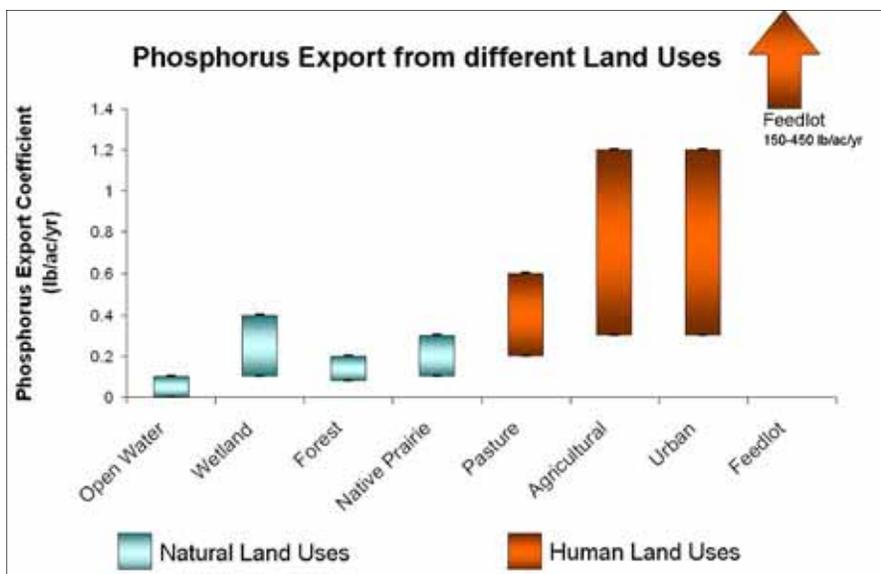
Figure 2. Phosphorus export coefficient for natural vs human land uses.

Phosphorus export, which is the main cause of lake eutrophication, depends on the type of land use occurring in the lakeshed. Phosphorus export (in lbs/acre/year) can be estimated from different land uses using the phosphorus export coefficient. Figure 2 shows the phosphorus export from the natural landscape versus human land uses. Humans alter the landscape, thereby adding more phosphorus to the lake than would occur naturally.

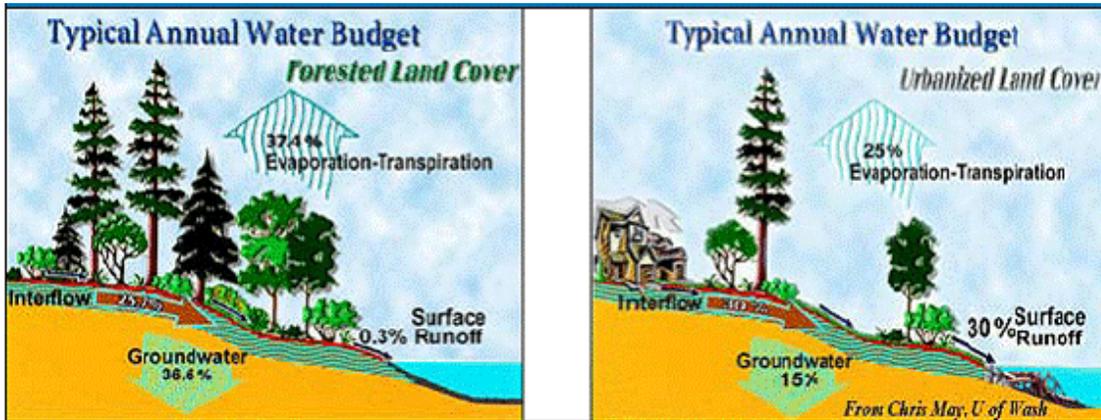
Figure 2. Differences in annual water budget from natural land cover to urbanized land cover (Source: May, University of Washington).

The changes in the landscape that occur during the transition from rural and open space to urbanized land use have a profound effect on the movement of water off of the land. The problems associated with urbanization originate in the changes in landscape, the increased volume of runoff, and the quickened manner in which it moves (Figure 3). Urban development within a watershed has a number of direct impacts on downstream waters and waterways, including changes to stream flow behavior and stream geometry, degradation of aquatic habitat, and extreme water level fluctuation. The cumulative impact of these changes should be recognized as a stormwater management approach is assembled (MPCA 2008).

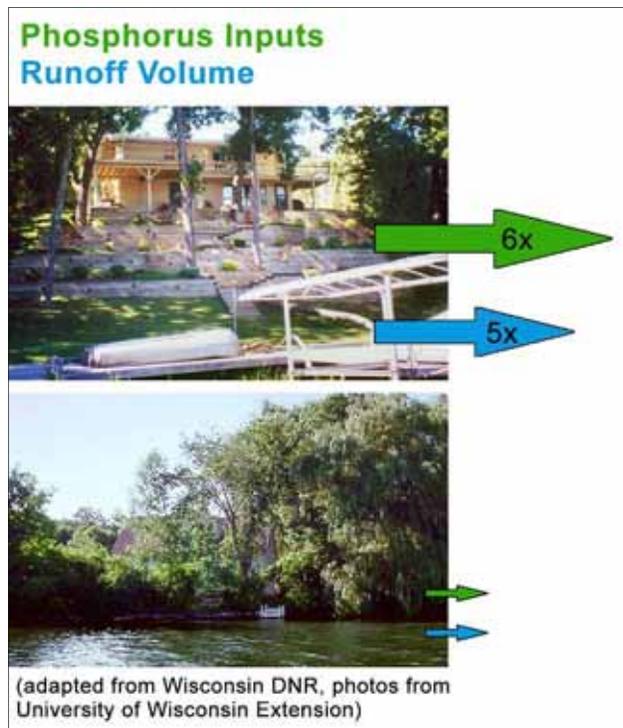
Figure 3. The effects of development on the amount of phosphorus and total runoff from a shoreland property. A large landscaped lot with a manicured lawn, a beach, and a retaining wall can increase total runoff volume by 500% and the phosphorus inputs to the lake by 600% (University of Wisconsin–Extension and Wisconsin Department of Natural Resources. 2002).
